EARTHQUAKE PERFORMANCE OF AUSTRIAN DAM, CALIFORNIA DURING THE LOMA PRIETA EARTHQUAKE

By John Vrymoed¹, Wallace Lam²

Abstract

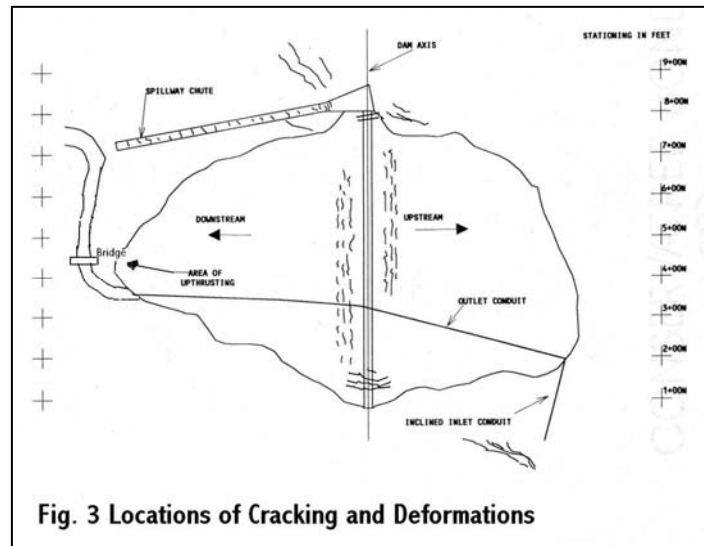
Fig. 3 Locations of Cracking and Deformations

The plan view of Austrian Dam with the earthquake induced cracking is shown in Figure 3. The cracking and movement are categorized as follows: 1. down slope movement of the right abutment causing severe damage to the spillway in the form of tension cracks along its entire length; 2. significant cracking and displacement at the embankment and spillway wall contact at the right abutment; 3. down slope movement of the left abutment near the sloping intake tower in the form of shallow surface sliding; 4. 60-foot wide zones of parallel cracks on both the up and downstream slopes parallel to and below the crest; 5. upthrusting at the downstream toe; 6. through going en-echelon transverse cracking of the crest near the left abutment to a depth of 32 ft.

There was significant evidence of compression and upthrusting at the downstream toe. A bridge located near the toe was moved off its foundation and displaced downstream 18 inches. Any evidence of upthrusting at the upstream toe was concealed by the reservoir. There was no evidence of cracking on the crest other than the transverse cracking near the abutments. Neither was there any evidence of cracking below the zones of parallel cracking on either slope near the crest.

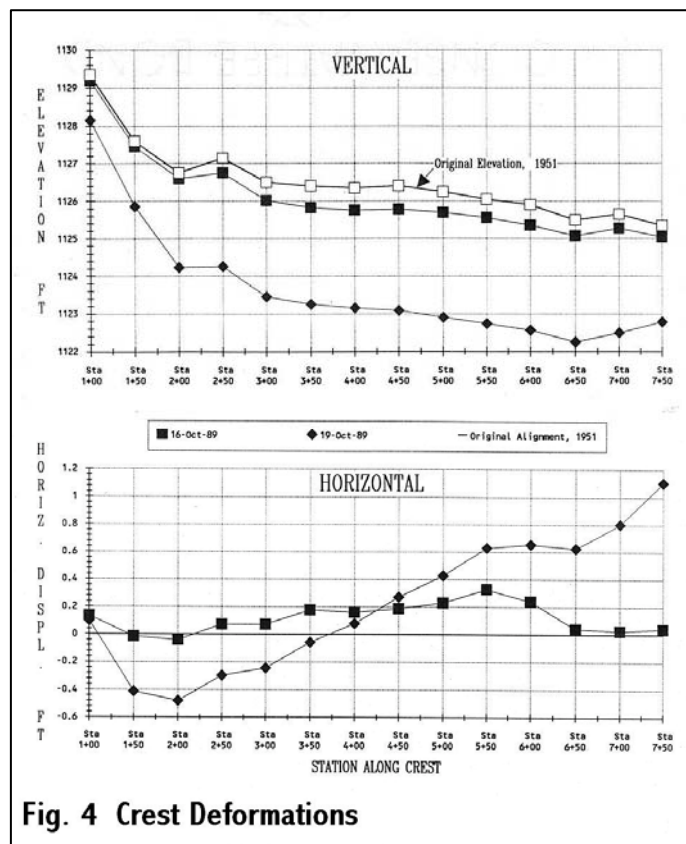
Fig. 4 Crest Deformations

The largest vertical displacement was 2.8 feet. Starting from Sta. 1+00 at the right abutment, the horizontal displacements were in an upstream direction up to Sta. 3+60. From there, the horizontal displacement reverses direction indicating a net downstream displacement. The large downstream displacements of the last two stations near the spillway were attributed to sliding of the right abutment. Except for these, the earthquake induced displacements are an amplification of the historic displacement due to the static stress conditions since the dam's construction.

The horizontal crest displacements between Sta. 6+00 and the spillway were therefore heavily influenced by displacement of the right abutment. This can be seen on Figure 4 which shows the horizontal displacements increasing dramatically when the right abutment contact is approached. This is accompanied by lesser amounts of longitudinal cracking on the downstream face. As a result, movement in a downstream direction dominated, causing a net horizontal crest displacement of 0.4 feet.

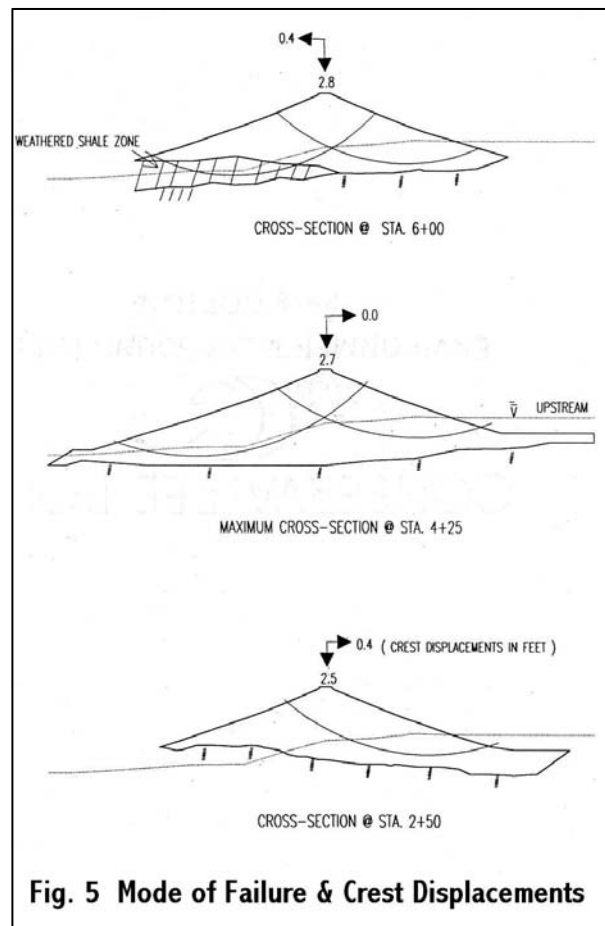
Fig. 5 Mode of Failure & Crest Displacements

The mode of failure became clear when the presence, as well as absence, of longitudinal cracking below the crest were examined. The locations of longitudinal cracking were superimposed on three cross-sections taken perpendicular to the crest at stations 2+50, 4+25, and 6+00 as shown in Figure 5. Also shown are the corresponding vertical and horizontal measured crest displacements. The phreatic surface measured at Sta. 4+25 just before the earthquake has been superimposed on the other two cross-sections. Also shown in Figure 5 is the postulated mode of failure of deep seated shearing within a shear zone. In this mode of failure the longitudinal cracking on one side

Sta. 6+00 The embankment at Sta. 6+00, which is near the right abutment, is postulated to have experienced deep seated shearing in both directions. This resulted in upstream displacement due to shearing through the saturated portion of the upstream embankment fill and downstream displacement due to instability of the materials forming the right abutment.

Sta. 4+25 The cross-section at Sta. 4+25 represents the maximum section. The embankment at this station is symmetrical except for a slight rise in the elevations of the upstream foundation contact and phreatic surface. Because of the near symmetry, the horizontal displacements, as a result of deep seated shearing, canceled one another. A vertical displacement of 2.6 feet was measured at this station.

The only plausible mode of failure is deep seated shearing. In this mode of failure, the up and downstream portions of the embankment slide as a result of shearing through a defined zone. The wedge forming the crest also behaves as a rigid block and acts like a graben with respect to the slopes. This indicates that, during high levels of acceleration, the embankment can no longer act as a continuum as the slopes act independently of one another.

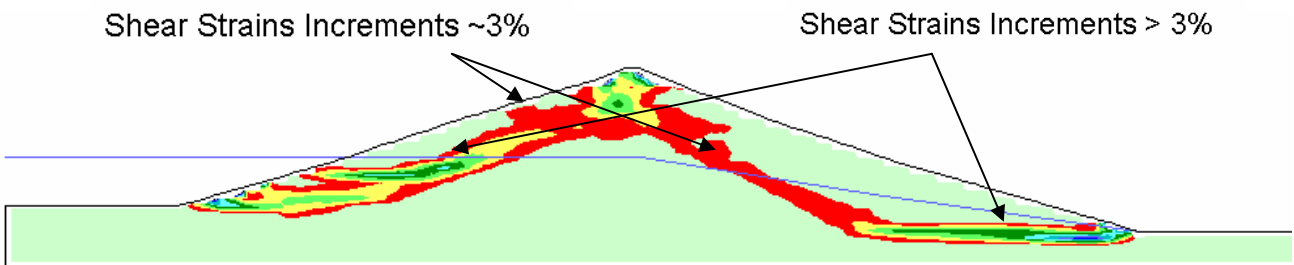
Figure 11: Shear Strain Increments during LPEQ Shaking

The maximum cross-section at STA. 4+25 was modeled with the reservoir elevation and phreatic surface at the time of the earthquake. Areas of shear strain concentration are shown Figure 11, which indicates distinct bands of averaging approximately 3 percent. This shear strain is equivalent to that calculated in the decoupled analysis and is slightly greater than the 2.7 percent back calculated from field measurements.

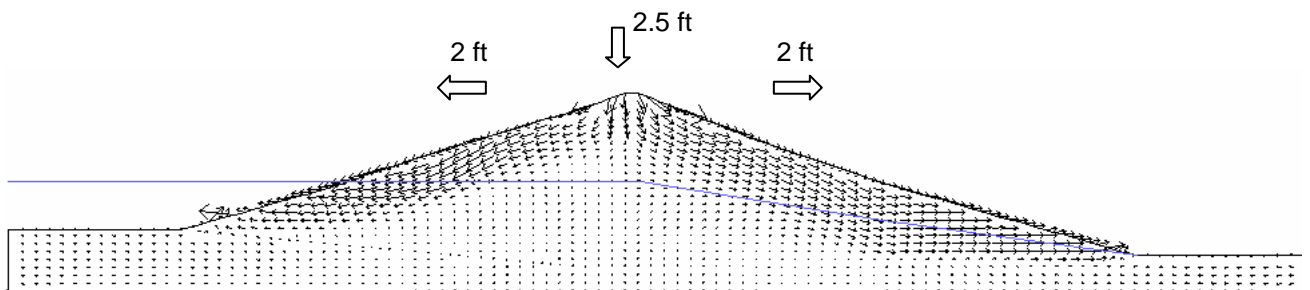
Figure 12: Displacement Vectors

The earthquake-induced displacements of the upstream and downstream slopes, shown in Figure 12, can be characterized as blocks moving in opposite directions. The displacement vectors gradually diminished with depth indicating the lower center portion of the embankment was not affected by the earthquake.

The up and downstream blocks intersect near the crest, resulting in an average vertical deformation of 2.5 ft in the upper 20 ft of the embankment. The analysis also predicts compression bulges at both toes.

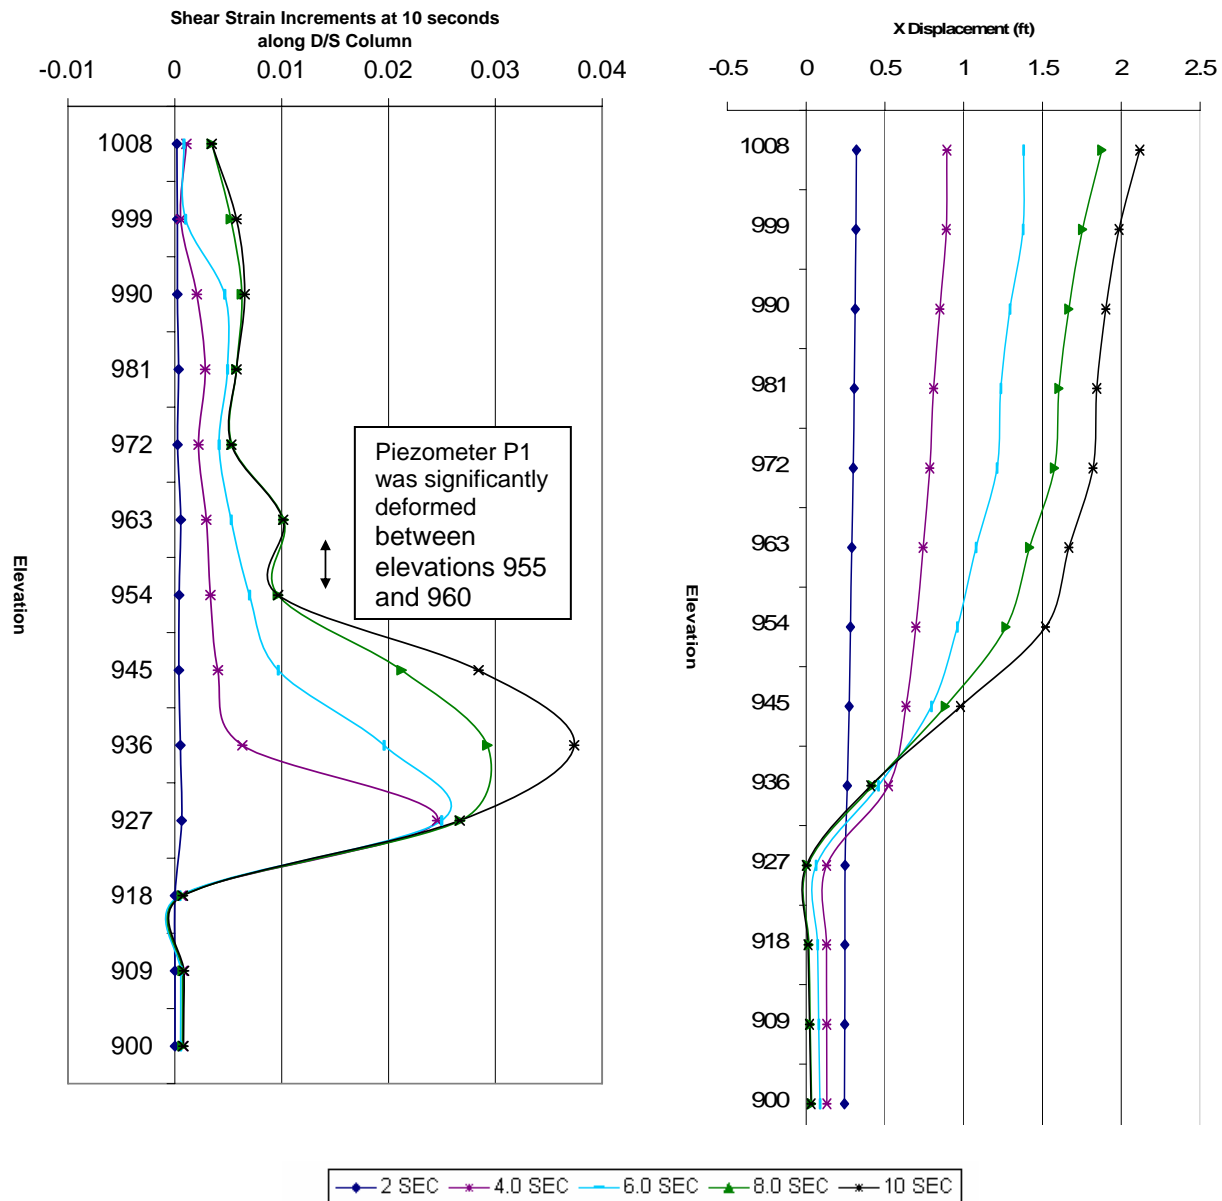
Figure 13: Displacement/ Shear Strains Vertical Profiles – Downstream Slope

Lateral displacements and shear strains were plotted with depth, shown in Figure 13, at a vertical alignment through the downstream slope, connecting piezometers P1 and P2, approximately two thirds of the way down the slope. The plots are shown at different points in time during the earthquake. Also shown on this Figure is the location where the

piezometer tubing was bent which is shown to be coincident at a depth where the shear strains dramatically increase.

The FLAC predicted shear strains and displacements, shown in Figure 13, are similar to those postulated in the decoupled analysis, shown in Figure 7. FLAC predicts the extent of shearing to occur over a depth of 45 feet which is less than the 60 feet observed on the extent of longitudinal cracking on the slopes. It also predicts the extent of shearing, at depth, to increase during the earthquake time history. The resultant displacement of the downstream block is about 2 feet which is equal to the computed displacements at Sta. 4+25 as shown in Tables II and III.

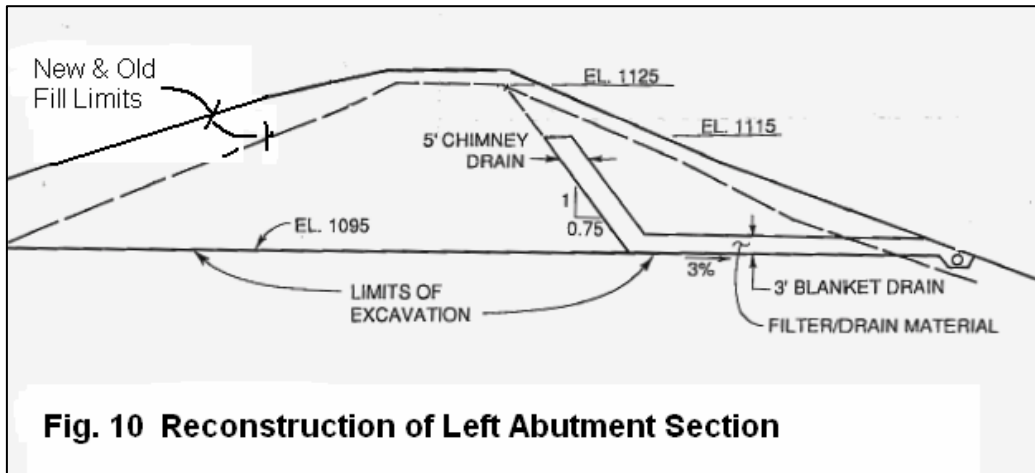
uncontrolled release by either, cracking at the spillway wall/embankment contact, and/or the transverse cracking. The latter was found to extent to a depth of 32 feet – more than twice the available freeboard. The repairs that were undertaken would not have been possible with a full reservoir. The spillway, which was severely damaged, was quickly repaired in preparation of the fall rainy season and a new spillway subsequently constructed on the opposite abutment. The upper portion of the embankment was excavated at both abutments and reconstructed with internal drainage as a mitigation measure against transverse cracking, as shown in Figure 10.
